TRANSMISSION **722.901**

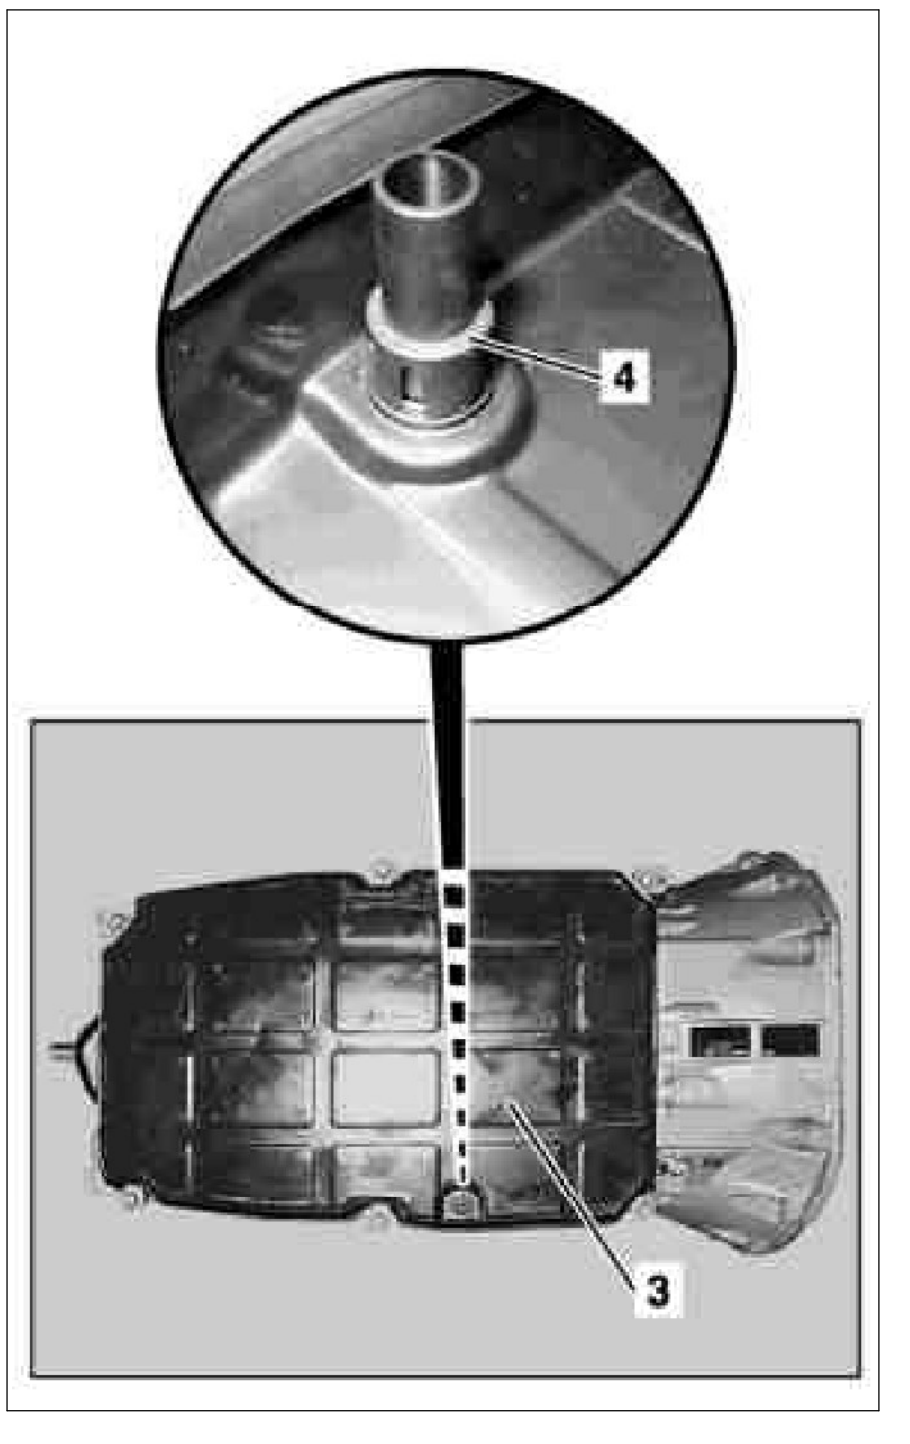
P27.10-2139-06

To improve fluid supply to the transmission, the transmission oil pan and the overflow tube have been redesigned.
The characteristic sloped surface (arrow) can be used to identify the new oil pan (1). This oil pan configuration should be installed only together with the white overflow tube (2).

The fluid temperatures used as references for checking and refilling are different with the new components.

Whenever a transmission is removed for repairs, the earlier oil pan (3) with the black overflow tube (4) should be replaced by the new sloped-surface version (1) with the white overflow tube (2).
